LEAD PAINT INSPECTION REPORT

INSPECTION FOR: Head Start @ Central Avenue Complex
1 Medical Drive
Parsippany-Troy Hills, NJ 07054

INSPECTION DATE: 09/09/2020

INSTRUMENT TYPE: Hueresis Pb 2000i
XRF Lead-Based Paint Analyzer
Serial Number: 2609

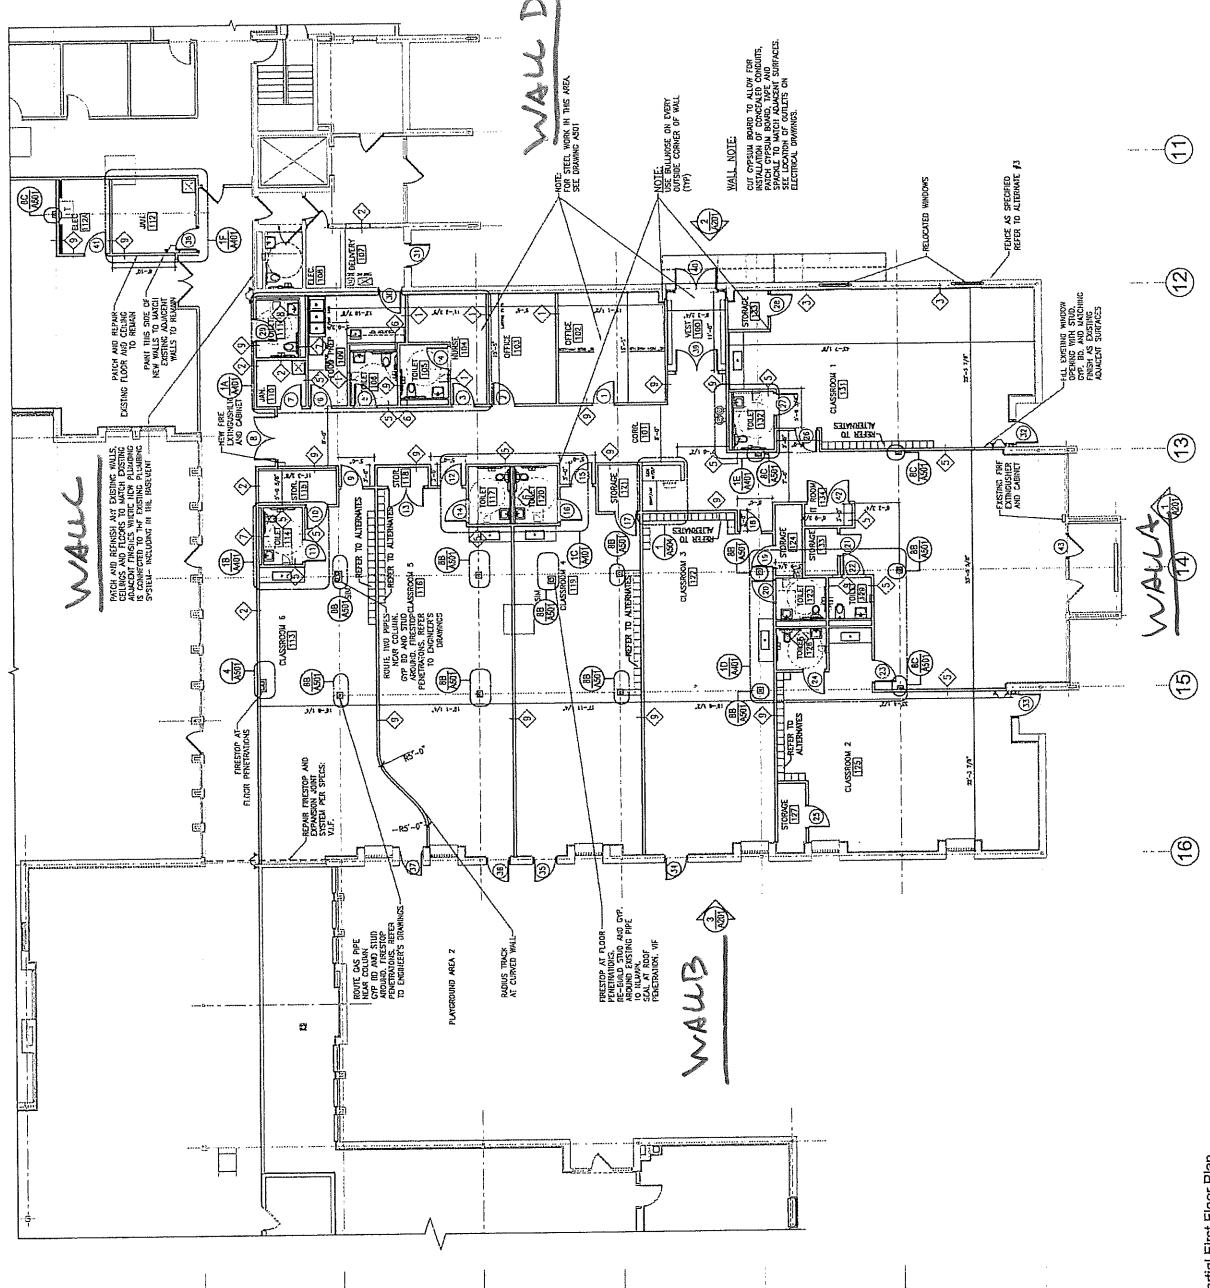
1 Partial First Floor Plan
A101 SCALE: 1in = 1'-0"

First Floor Plan
118819.01
Drawn by:
Checked by:
